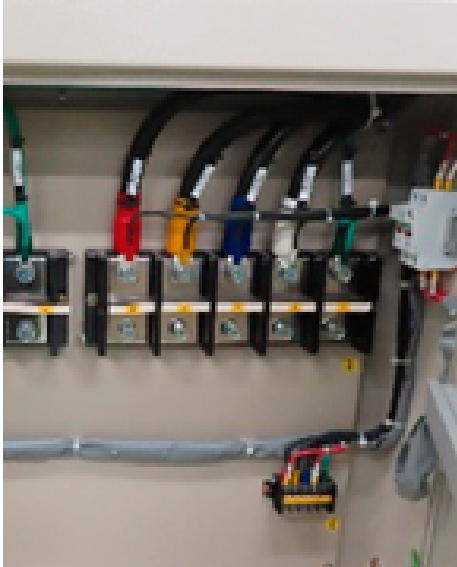
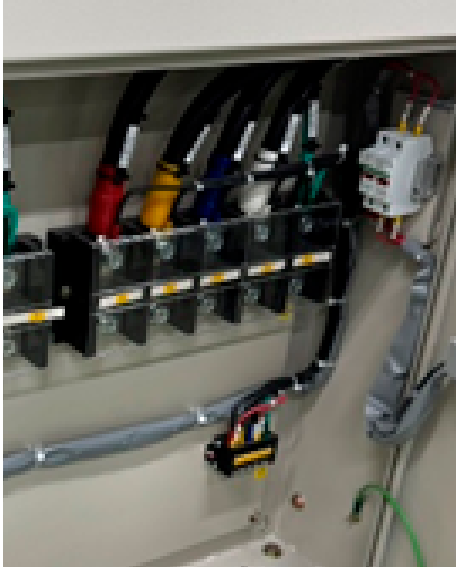
Number	Management approach	Explanation	Improvement Measures
5	Electric Shock Hazard Analysis in Laboratories	Distribution panels and metal connectors in the laboratory were not equipped with partition plates or acrylic insulation covers as required, posing a risk of electric shock during operation.	To prevent electric shock hazards, it is recommended to install partition plates or acrylic insulation covers throughout.

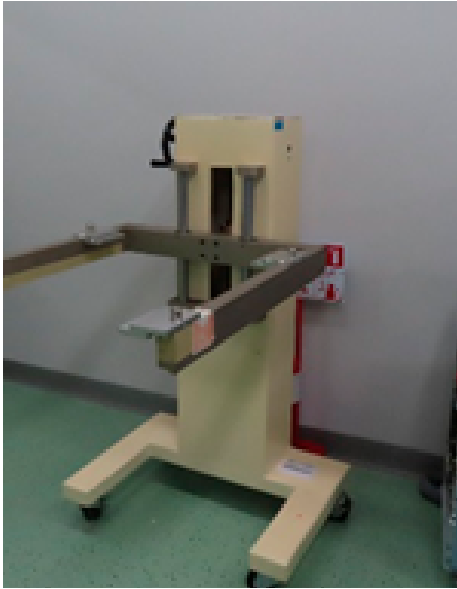
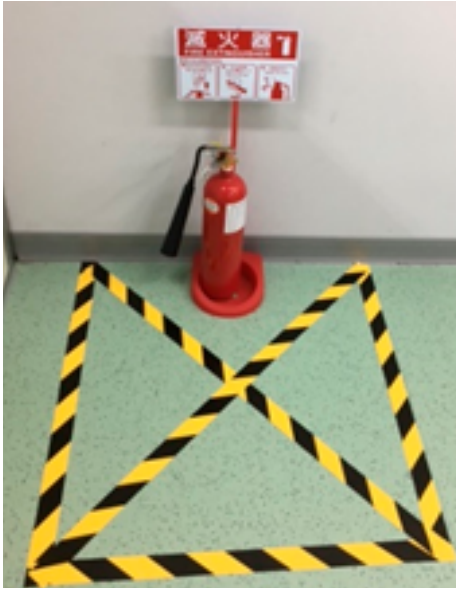
6	Obstructed Fire Extinguisher	In the laboratory, fire extinguishers were found to be obstructed by objects, compromising fire safety.	The area in front of the fire extinguisher has been cleared and marked with warning tape to prevent obstruction and ensure emergency accessibility.

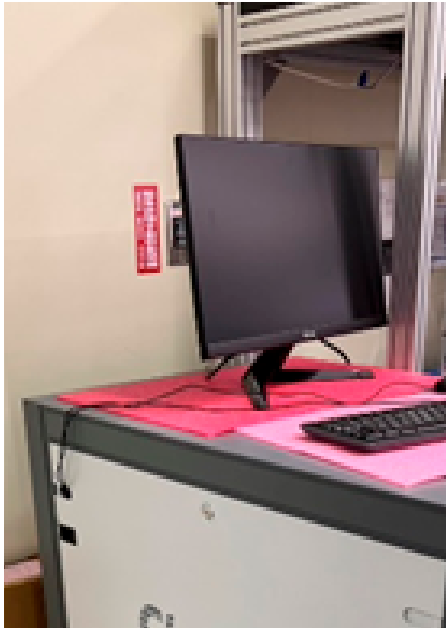
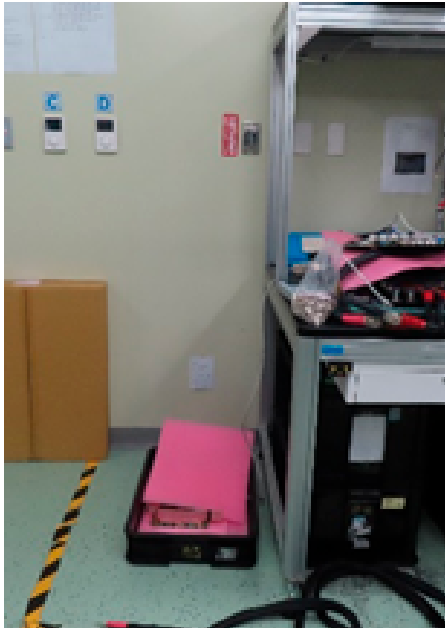
Number	Management approach	Explanation	Improvement Measures
7	Obstructed Emergency Smoke Exhaust Switch	In the laboratory, the emergency smoke exhaust switch was found to be obstructed by objects.	The area in front of the emergency smoke exhaust switch should be cleared to prevent obstruction and ensure emergency accessibility.

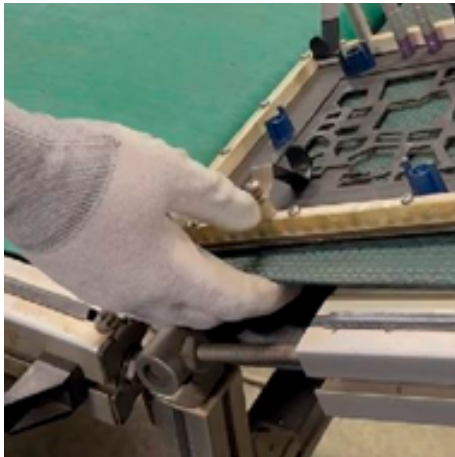
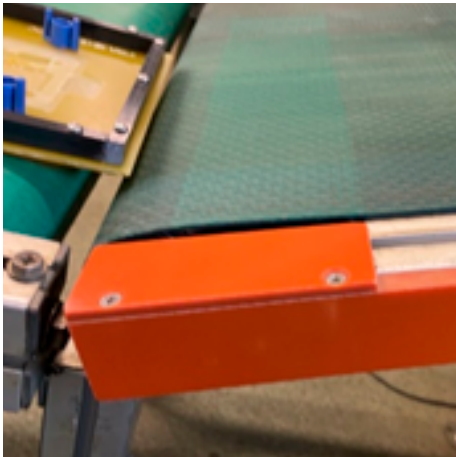
8	Pinch Point Hazard Analysis of Conveyor Belt Gaps	A large gap was found at the end of the conveyor belt, posing a risk of fingers being caught in the roller when personnel retrieve materials.	A cover plate has been installed over the gap to prevent fingers from accidentally entering the space and being caught in the roller.

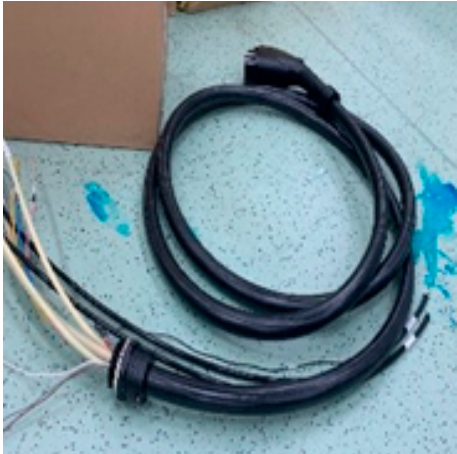
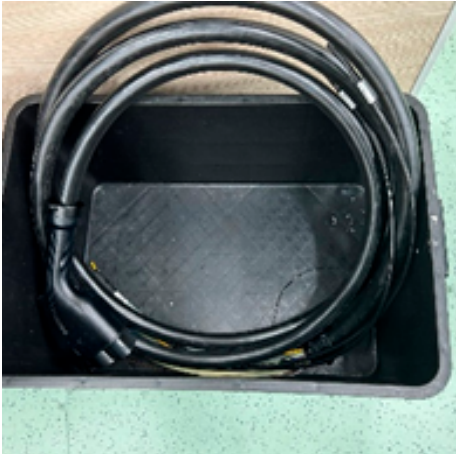
Number	Management approach	Explanation	Improvement Measures
2	Hazard Assessment of Exposure to Hazardous Chemicals	Chemical containers exceeding 100 ml without complete GHS labeling and without a spill tray may result in coolant leaking from the tubing onto the floor, posing risks of environmental contamination and employee exposure.	The chemicals were replaced with containers bearing complete GHS labels. In addition, plastic tubing was configured into a closed-loop system and placed within a spill tray to prevent coolant leakage.
